MARINE INVESTIGATION REPORT

M99W0137

CAPSIZING WITH LOSS OF LIFE

THE INFLATABLE RIVER RAFT "FLIP"
SULPHUR RIVER, GRANDE CACHE, ALBERTA
12 JULY 1999

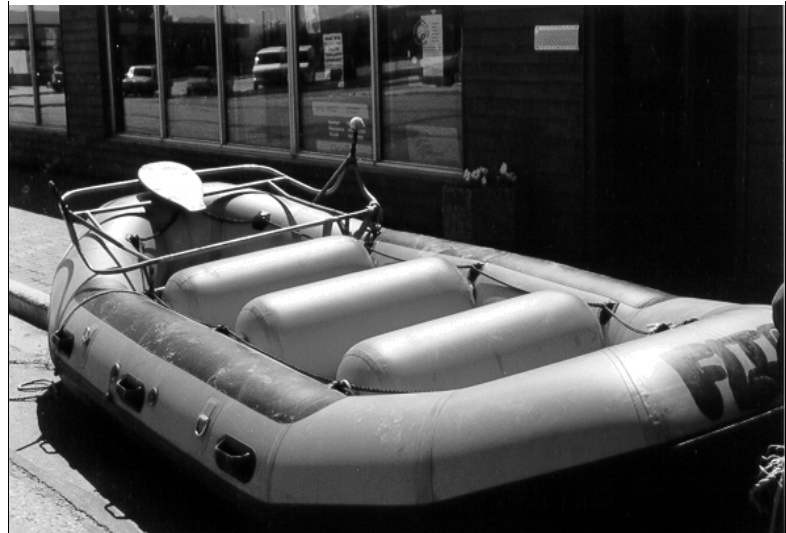
Photo 1
The "FLIP"

The steering frame of the river raft “FLIP” was damaged when the raft upset while travelling down an embankment toward the launching point on the shore of the river. This damage affected the raft’s steering to the extent that the raft’s descent of the river was interrupted and the help of the passengers was enlisted to pull the bent steering frame into a position deemed satisfactory to the trip leader. It is not known if the bent steering frame was a factor in the subsequent loss of control of the raft at the *ledge*.

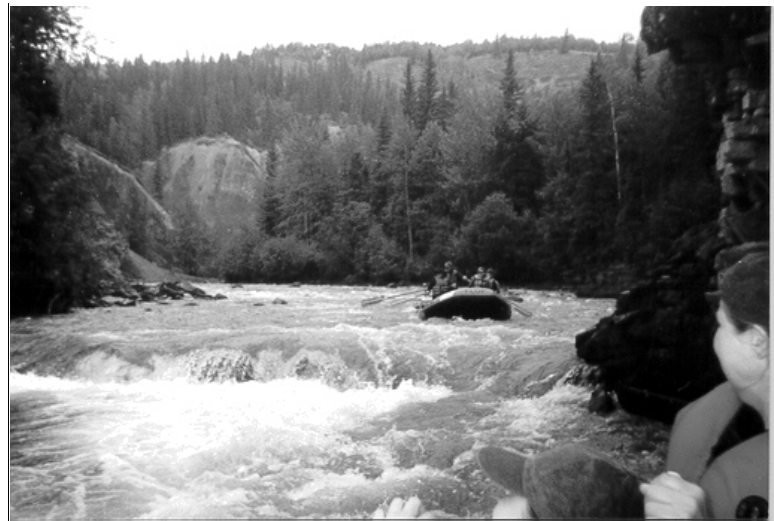
Photo 2

The "FLIP" went over the *ledge* with its starboard side leading; it rolled to starboard and then to port, and then capsized. All occupants were spilled out of the raft and into the water. Of the six occupants, two surfaced beneath the upturned raft while the remainder found themselves adjacent to it. The two passengers beneath the raft, by their own efforts, swam clear; one upstream, the other downstream. The raft was undamaged.

A raft approaching the *ledge*

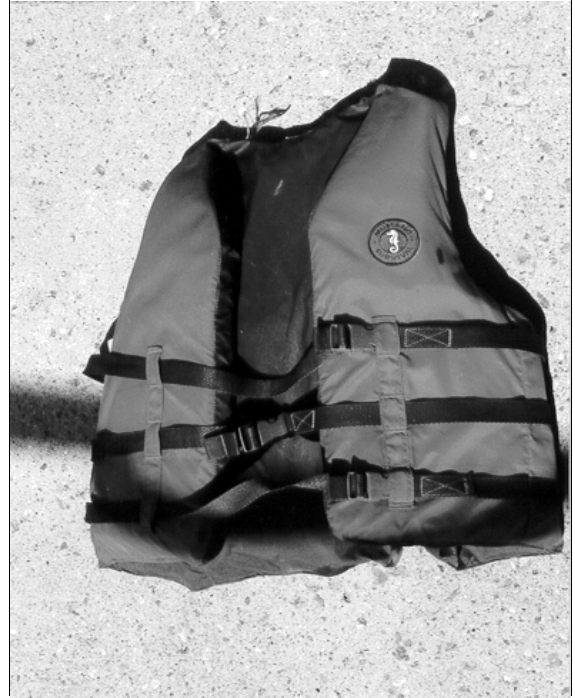
Photo 3

None of the PFDs provided by the trip leader for the use of his passengers were designed to meet the requirements for a “standard lifejacket” in either performance or flotation. In particular, a PFD is not designed to turn an unconscious person in the water face up.

Personal flotation device worn by the victim

The PFD worn by the victim displayed signs of age and rough service. The PFD manufacturer’s information tag sewn on this PFD had, through use, become completely unreadable. The information tag of the PFD had been printed with the caution: “This device may lose buoyancy over a period of time and become no longer serviceable.” Other PFDs in the inventory of the trip leader were in a similar condition, some with torn fabric or missing buckles.

In this occurrence, the PFD was seen to have supported the victim face up when he was thrown from the raft when it capsized. The victim, who was later determined to have suffered a head wound, did not appear to be conscious. When he was recovered, however, he was no longer wearing the PFD. The PFD was recovered and was found to have remained buckled, indicating that it had slipped off the victim, who was most probably unconscious.
